Current Situation and Issues of Myanmar's Bridge Work

September, 2012

Japan Infrastructure Partners (JIP)

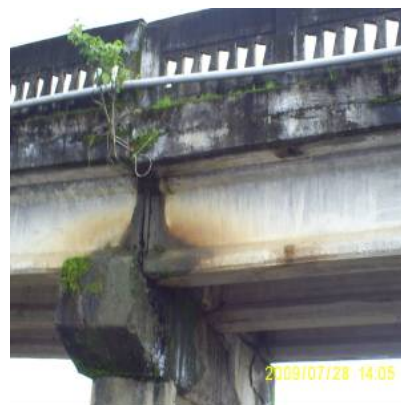
Photo-3.2 Concrete girder nearly from substructure

Photo - 3.2 shows a concrete bridge in service whose girders are nearly falling down from substructure. The superstructure appears to be PC girders, and it appears for some reason that manufactured precast girders were simply installed on the pier constructed in incorrect position (it is unlikely that it was left long time in this state with no measures taken, so this bridge was investigated in the 2011 study. The results will be discussed later).

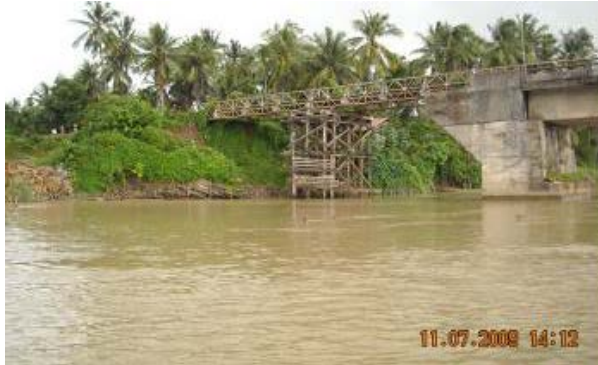
Photo-3.3 Passage of traffic was secured by using a temporary bridge when the rear face of an abutment was scoured during flooding

Photos - 3.3 & 3.4 show a case where the rear face of an abutment has been scoured. Photo - 3.3 shows a situation where the flow of traffic was secured using a temporary bridge. Photo - 3.4 shows the later situation where traffic was halted after flooding washed away a temporary bridge support. Judged from the date of the photos, it is thought that this trouble

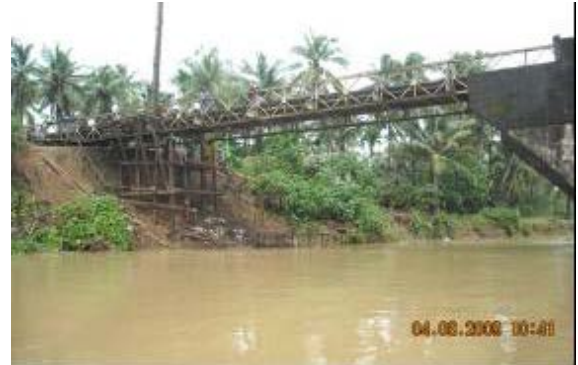
Photo-3.4 Subsequent flooding washed away the temporary bridge pier and traffic was halted

occurred after the inspection team's observation. Subsequently the bridge was apparently extended in a rush job using a 2-span concrete bridge.

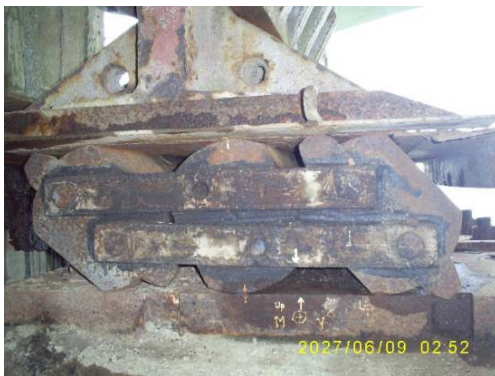
Photo-3.5 Deformed shoe of the Maubin Bridge (1)

Photos - 3.5 & 3.6 show deformed locker shoes on the Maubin Bridge which spans a branch river of the Irrawaddy on the Yangon-Pathein road.

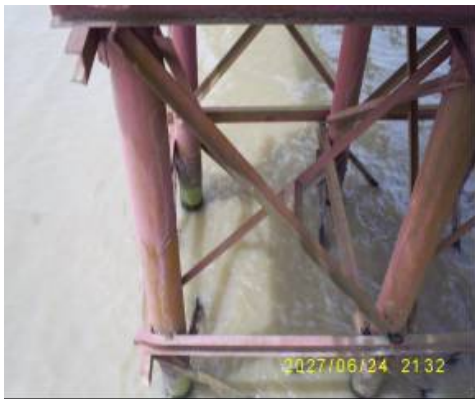
Photo-3.9 Pipe pier

Photos - 3.7-10 show the situation of a Bailey bridge and its pipe pier in the Irrawaddy delta area. Apparently, the pier of a similar bridge collapsed after observation by the inspection team. This region is prone to seawater intrusion, and it seems that the corrosion of a steel pipe caused the pier to collapse. Apparently, just after it collapsed, this bridge was reconstructed as a concrete bridge.

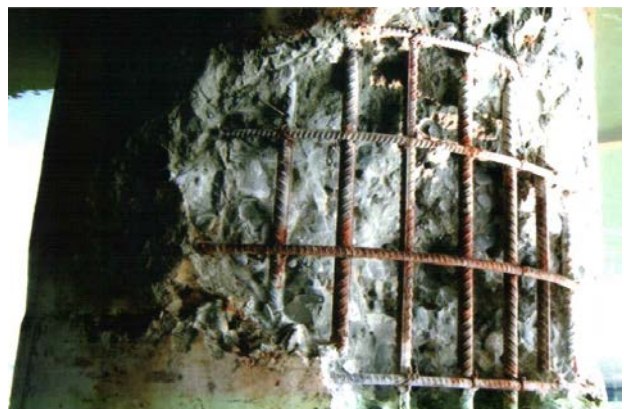
Photo-3.12 Section of poor execution at the pile top

Photos - 3.11 - 13 and Figure - 3.1 show defective construction work and later repairs to the upper section of cast-in-place concrete pile of the bridge foundations widely used in Myanmar.

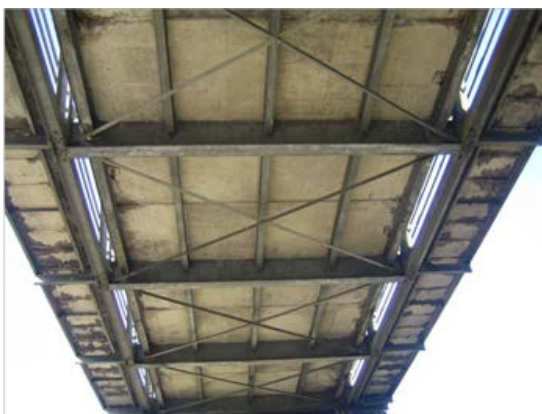
Photo—4.2 Concrete slab of Kyaunkong Bridge

The concrete slabs of this truss bridge were designed under Swiss technical guidance. Though the lower section of the slabs uses 3.5 inch thick precast concrete members with tensile longitudinal rebars placed within, there was no particular consideration of integration with the cast-in-place concrete section on top.

While it is thought that this type concrete slabs cannot withstand substantial repetitive loading by heavy vehicles, no particular signs of deterioration have been seen as yet (Photo 4.2).

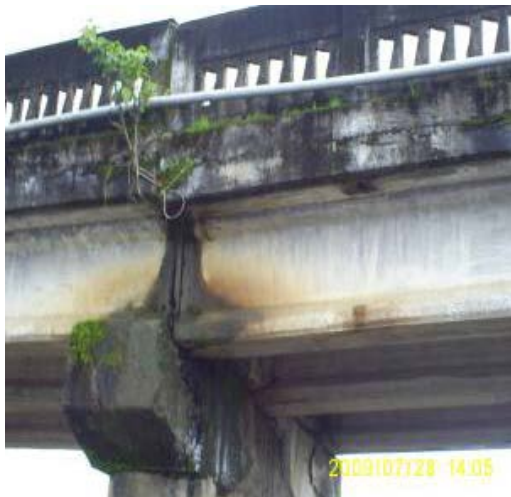
Photo-4.4 Concrete girder nearly falling from substructure

The Thakhut Bridge is a prestressed concrete girder bridge constructed in 1991 in the delta (soil in this area is very soft when compared to the Irrawaddy delta) of the Yangon opposite shore side of Yangon City, and a girder of this bridge noted in the 2010 report was nearly falling from the bridge substructure (Photos 4.3 -5).

When an abutment moved during construction and a concrete girder was nearly falling from the central pier, as noted in the 2010 survey report, naturally the pier top would have been widened at that time. Similarly, the pier is rather far from the abutment so it is unlikely that this pier moved when the abutment moved.

The river channel around this bridge section has moved in these 20 years after construction, and the riverbed level changed also. In other words, it is believed that the elevated riverbed caused lateral flow of soft ground soil and the pier above was moved.

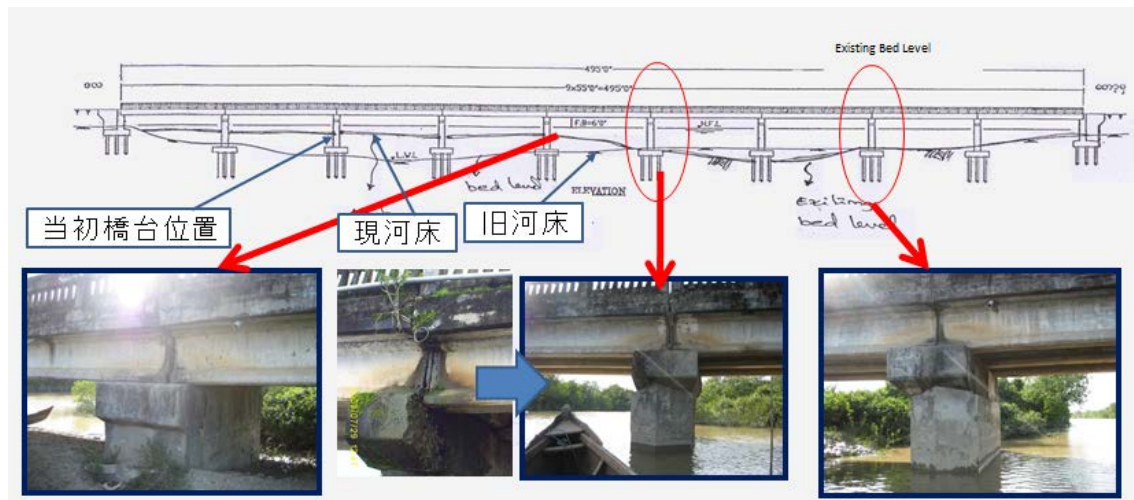
Figure-4.1 General view and Photos(before and after)

Figure 4.1 shows the general view and photos before and after widening of the top of the pier (the general view was drawn in the opposite direction to the direction the photos were taken).

The abutment of the Yangon side moved forward substantially when the rear embankment of the abutment was filled, and in response, a 2-span concrete girder bridge was extended on the Yangon side.

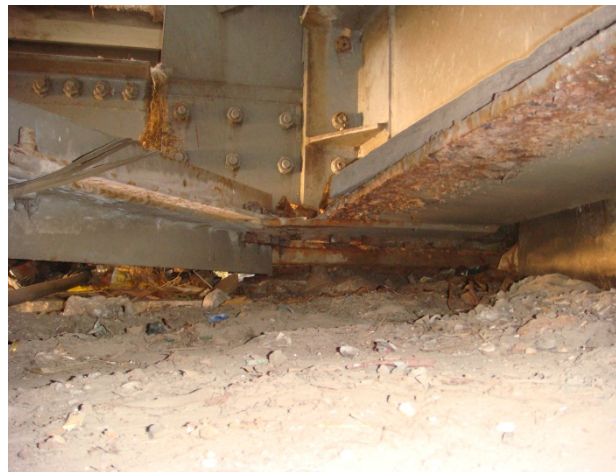
Photo—4.9 Movable shoe (Yangon side)

Soil condition in this area is typically of soft layers (Fig. 4.3), and the Yangon opposite abutment has been pushed forwards due to earth pressure on its rear embankment and gave compressive force on the truss superstructure. In 2003, large-scale repairs work was done by suspending the traffic.

Photo 4.9 shows a movable shoe on the Yangon side of which bearing plate was elongated. The shoe on the opposite shore side, as shown in Photo 4.10, appears to be functioning comparatively soundly.

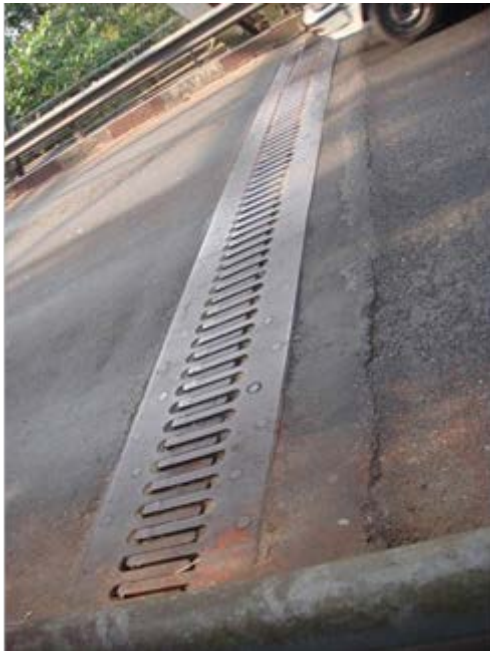
Photo-4.11 Expansion joint
(Yangon side)

As for the expansion joints on both sides, the teeth began to collide so in response the claw was cut during large-scale repairs. However, at present the gap of the expansion joint has disappeared (Photo 4.11), and partial fractures can be seen in some sections (Photo 4.12). So it is thought that the abutment is still moving and countermeasures would be required.

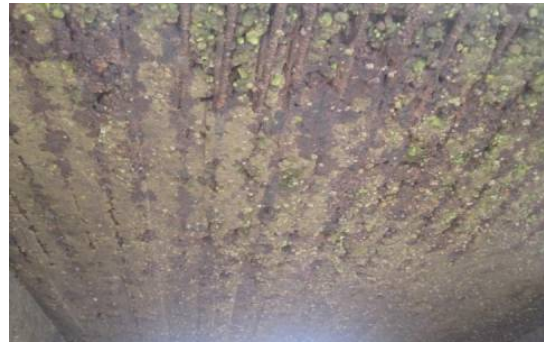
Photo-4.14 Underside of a pile cap

Photo 4.14 was taken at the time of the full inspection in 2009 and shows the situation of the underside of the top slab (known as a "pile-cap" within PW) supporting the bridge pier. The rebars are exposed.

Coverless of Pile Cap bottom surface
at Bayintnaung Bridge

It is thought the design and execution requires investigation when it's used in deep river.

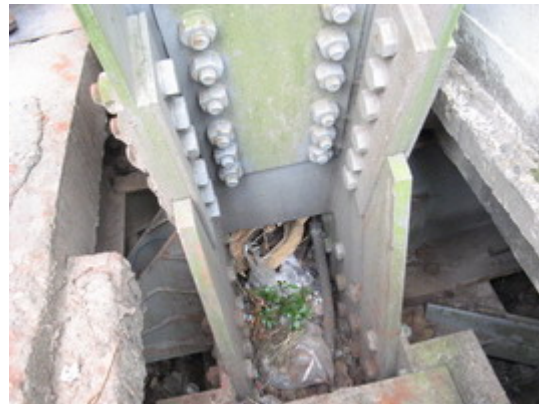
Photo-4.16 Dust at panel point

Rubbish has collected at the panel points of the trusses, and such a state is susceptible to corrosion (Photos 4.15 & 16). Preventing corrosion of truss panel points was suggested as a crucial maintenance item.

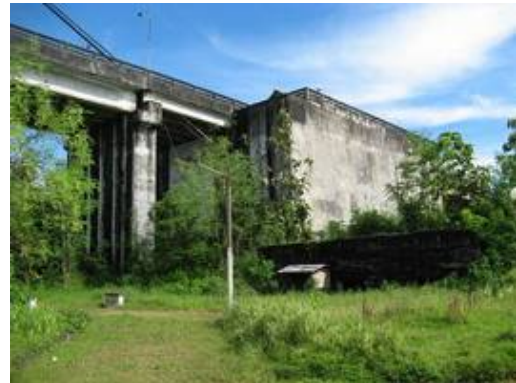
Photo-4.18 Anchorage (south side)

An abutment of this bridge moved forward while erecting the main cable, the embankment on the rear face of the abutment was changed to a concrete bridge in order to eliminate earth pressure from the rear face of the abutment, and piles were cast around the abutment as a countermeasure. Photo 4.18 shows the abutment on the south side. The top of the main tower was moved over 1m, and the inclination of the main tower can be seen in Photo 4.19.

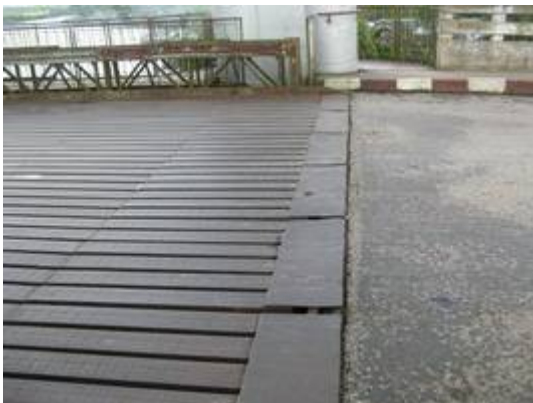
Photo-4.23 Expansion joint

The connection between the main cable and hanger has been corrosion proofed using a material thought to be cement mortar and as shown in Photo 4.22, the main cable has simply been passed straight through the flooring. The road surface is comprised of I-type steel, and as can be seen from Photo 4.23, a simple expansion joint was used between abutments.

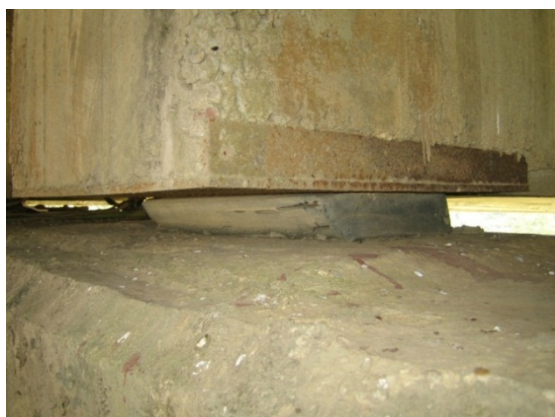
Photo—4.25 Rubber shoe subject to major shear deformation

In the same way as with the Bayinaung Bridge, the abutment that sits upon soft soil has moved forward due to earth pressure on its rear face, and this is thought to put pressure on the truss superstructure.

Photo 4.25 shows that the rubber shoe of the approach concrete bridge atop of the truss bridge's end pier has been severely shear deformed, and we can see that the pier has been pushed from the concrete bridge side.

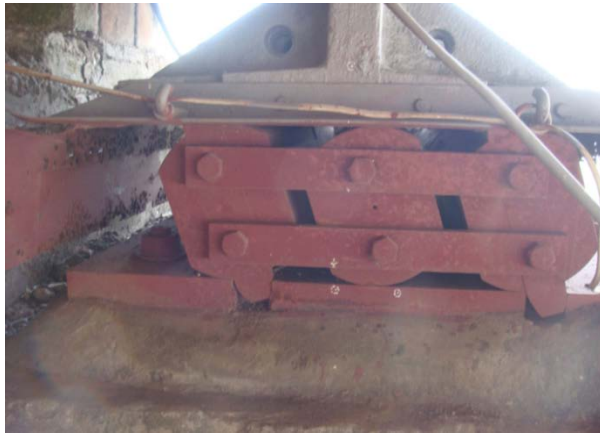
Photo-4.26 Shoe (Yangon side)

As shown in Photos 4.26 & 27, the main body of the locker shoe is greatly deformed, and

on the Maubin side the stopper of the lower shoe has become detached.

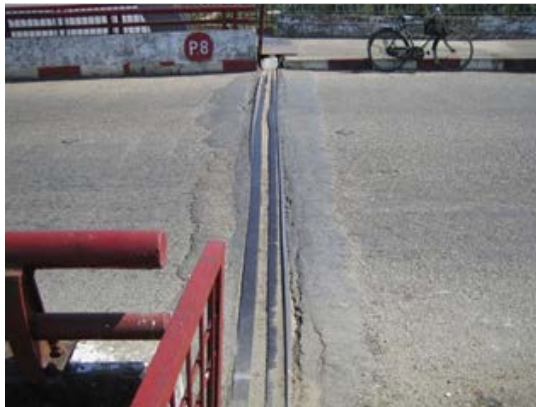
Photo-4.28 Expansion joint (Maubin side)

Likewise, Photos 4.28 & 29 show the expansion joint and parapet atop the abutment of the approach concrete bridge, and it is clear that earth pressure is acting on the rear face of the abutment.

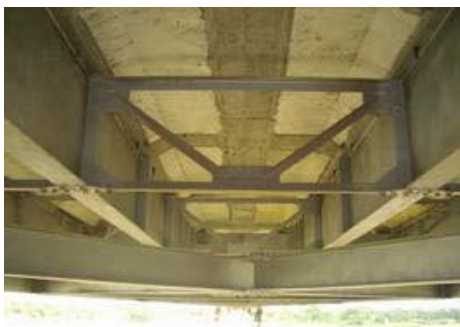
Photo—4.30 Precast concrete slab

This bridge also uses precast concrete slabs, though there are concerns about its durability since prestress has not been introduced into the cast-in-place concrete joint between the precast slabs (Photo 4.30).

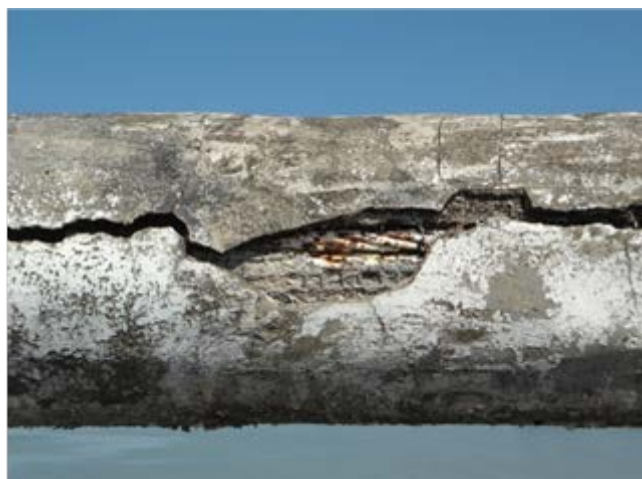
The coating of the cable has split, been chipped away, and corrosion can be seen on the exposed inner section of the cable. From the condition of the cable corrosion, the cable may not have been corrosion proofed (Photo 4.39).

Photo—4.39 Splitting and erosion of main cable cladding

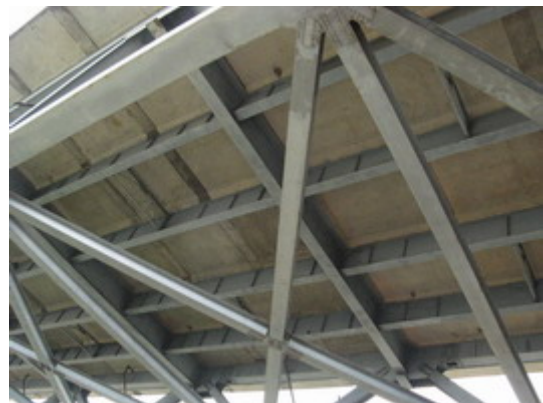
Photo-4.44 Precast concrete slab

The slab uses reinforced concrete precast slabs (Photo 4.44).

In Myanmar, due to the strict construction period required, precast slabs are used on-site instead of cast-in place reinforced concrete slab. At present no signs of deterioration such as joint leakage has been found, though the design and detailed structure requires investigation.

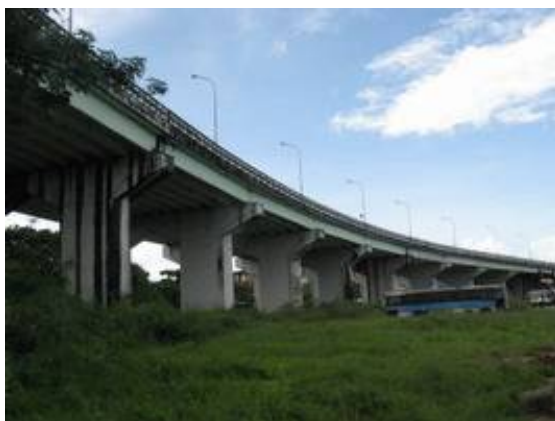
The concrete slabs of the approach concrete bridge (Photo 4.52) have been damaged several times a year over the past few years. Photo 4.53 shows the repairs to the slabs. When examining the cause of the damage to the slabs, necessary countermeasures need to be investigated.

Photo-4.52 Approach concrete bridge of Mahar Bandoola Bridge

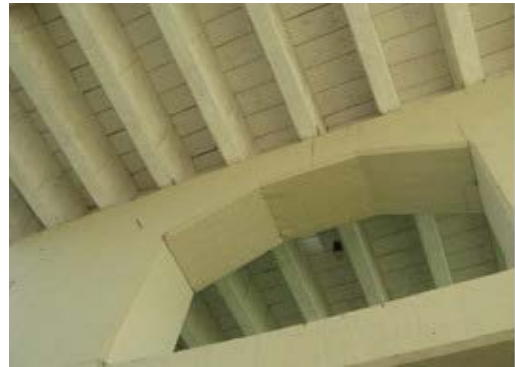
At the slab of the approach concrete bridge, due to shortening the construction period, a left-in-place material precast concrete formwork has been used on the underside of the slabs (Photo 4.58).

Photo-4.58 Slab of an approach concrete bridge

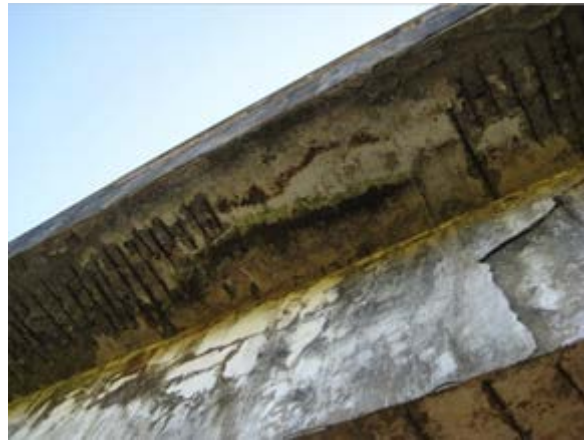
This is an area where obtaining a large quantity of freshwater is no doubt difficult and it is thought seawater was used in concrete mixing. The execution of the concrete is also not good (Photo 4.66 & 67)

Photo—4.66 Underside of an approach concrete bridge's walkway

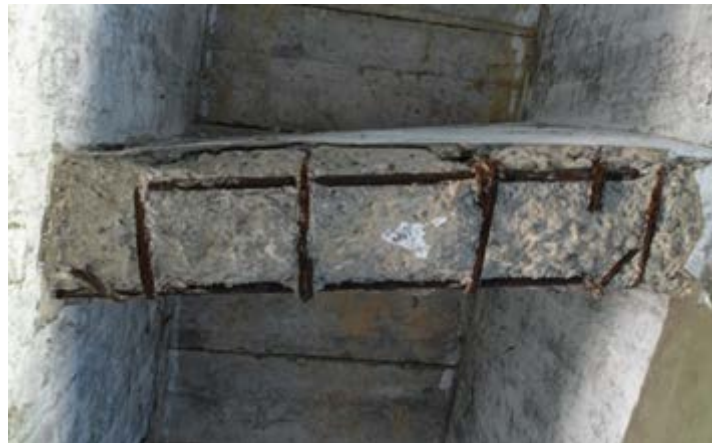
Photo—4.67 Cross beam of an approach concrete bridge

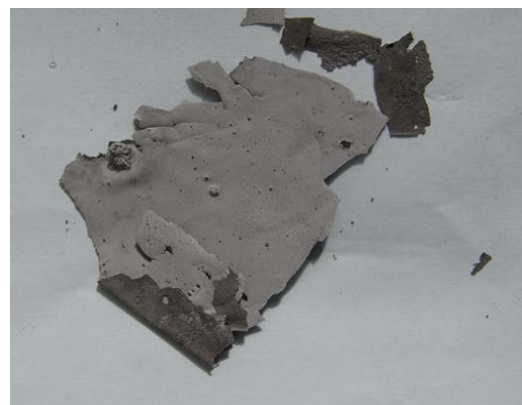
Looking at the corrosion of the steel members, as can be seen in photos 4.69 & 70, peeling of the paint film on the truss members can be seen over a wide area. Peeling of the paint film suggests that the paint itself has low adhesive properties, and the cause of the peeling requires investigation since the total destruction of paint film is regarded as a warning.

Photo-4.70 Peeled paint film

In some areas of peeling the film thickness is less than half, and since the anti-corrosiveness of those areas is greatly reduced, repainting (recoating) is urgently required as soon as the cause of the peeling is found.

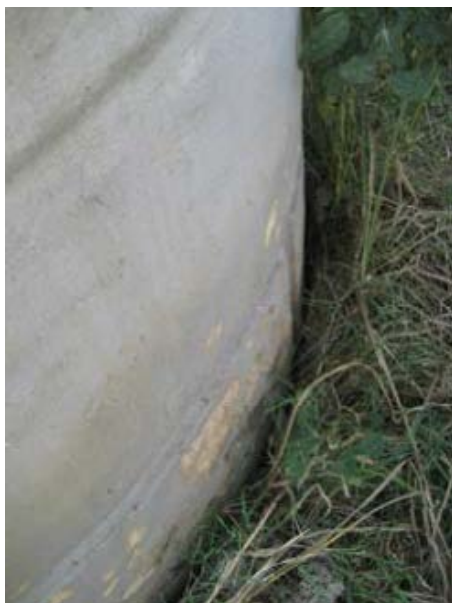
From looking at the ground surface layer surrounding the anchorage (Photo 4.79), the gap of the expansion joint of the approach concrete bridge (Photo 4.80), and the concrete peeling off the cross beam of the pier below (Photo 4.81), the change in camber is believed to be mainly due to the movement of the anchorage.

Photo-4.79 Gap between the main tower and the ground behind

The behavior of the suspension bridge needs to be measured urgently, and depending on the results, countermeasures may be needed to prevent the anchorage from moving.

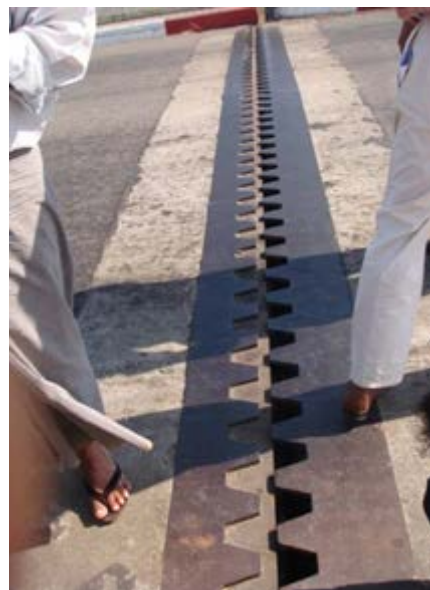
Photo-4.80 Gap of expansion joint 5

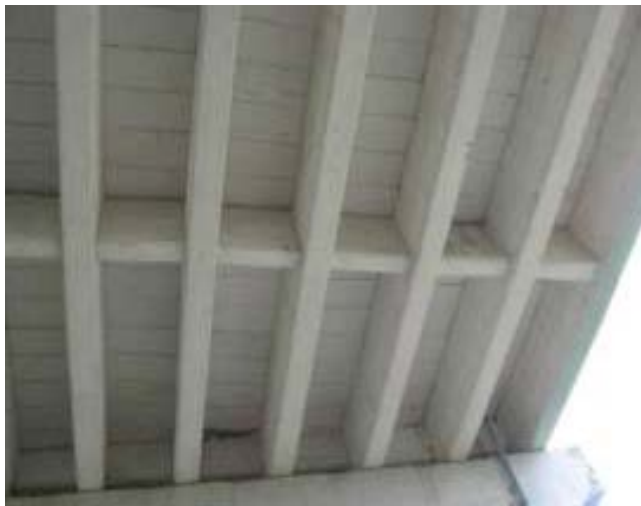
Type I is commonly used in concrete girder bridges (Photo 5.1, fig. 5.2). It uses precast panels only as formwork, and precast panels are ignored in the calculation of cross sectional strength. In this case, the cast-in-place concrete slabs are six inches thick, and it is feared that the cross-sectional thickness is insufficient depending on loading conditions.

Photo-5.1 Slab of concrete girder bridge (Type I)

This type of slab is used on the Mahar Bandoola Bridge which carries a high volume of traffic within Yangon City, and apparently slabs have been falling frequently in recent years.

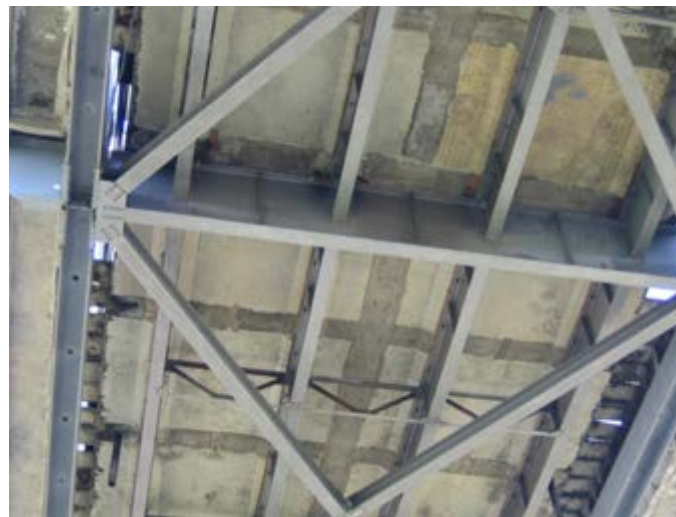
Photo—5.3 Precast slab of a general truss bridge (Type III)

While there are concerns over the durability of the cast-in-place concrete joints (prestress is not introduced) of the precast slabs, currently no signs of deteriorated joints have been seen.

However, since there are concerns that the joints will be damaged in the long-term, at some point it is thought countermeasures must be considered.

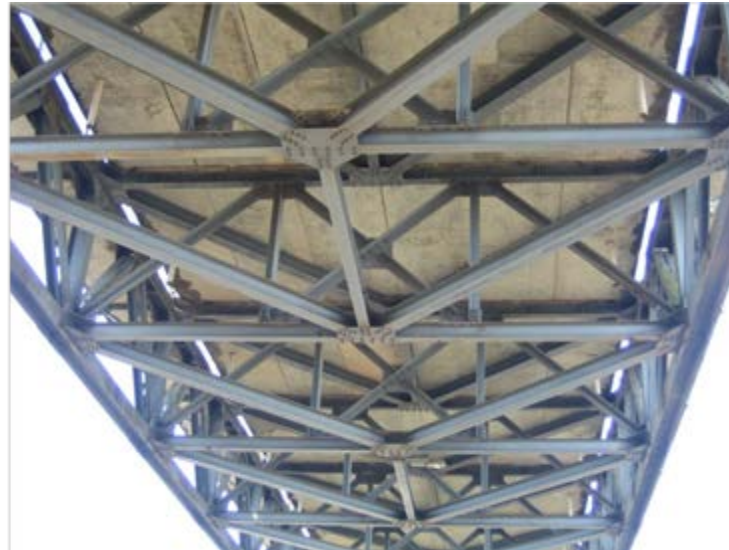
Photo—5.5 Type V slab

At present it appears to be in a sound state, with no anomalies seen in the longitudinal masonry joints of the precast slabs.

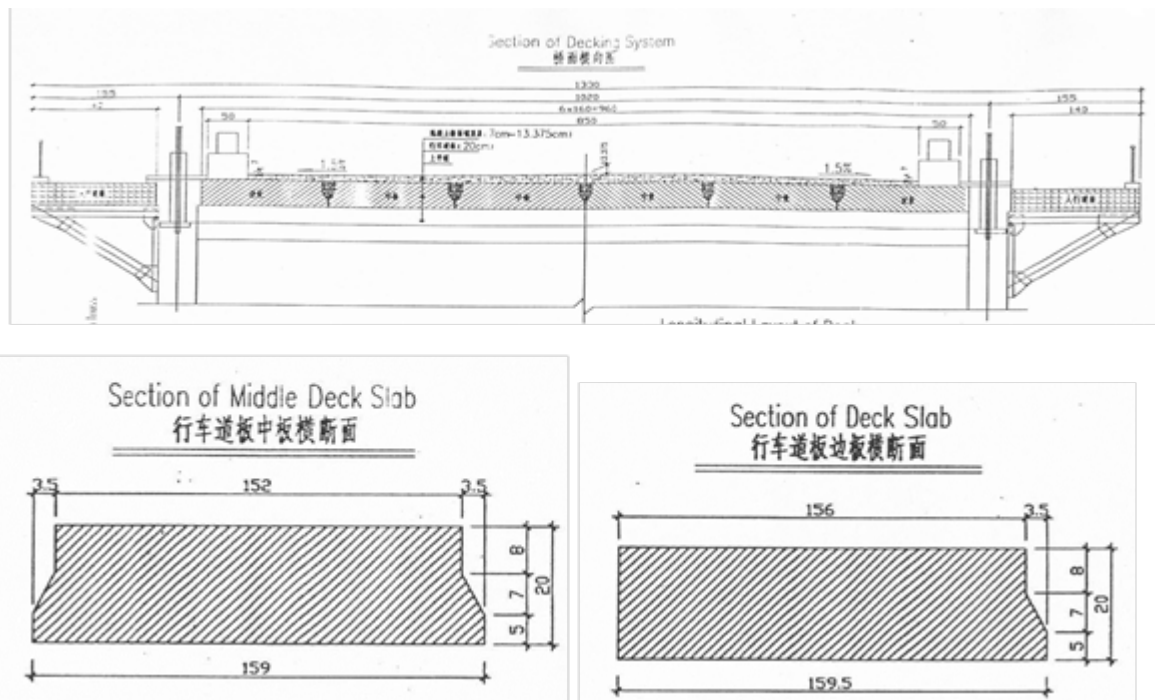
Figure—5.5 General view of Type V slab

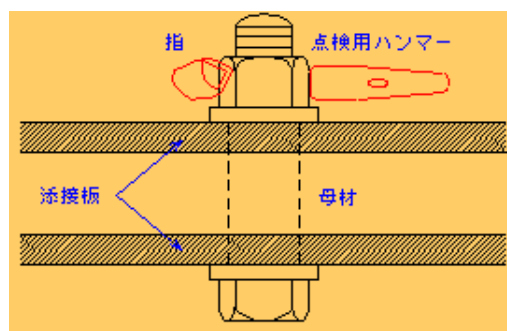
Figure—5.9 Inspection method

Likewise, it is also recommended to prevent any fracture of high-tension bolts by using an inspection hammer. They are to check for abnormal tactile sensations with the fingers, sounds and vibrations in all the bolts manufactured in the same batch as the damaged bolt, or all bolts in the same section of the joint (splice plate) as the damaged bolt.
